# MONTHLY PROGRESS REPORT

**PRIME RESIDENCIES EDMONTON ROAD**  
No 01, Edmonton Road, Colombo 05

**JULY 2019**

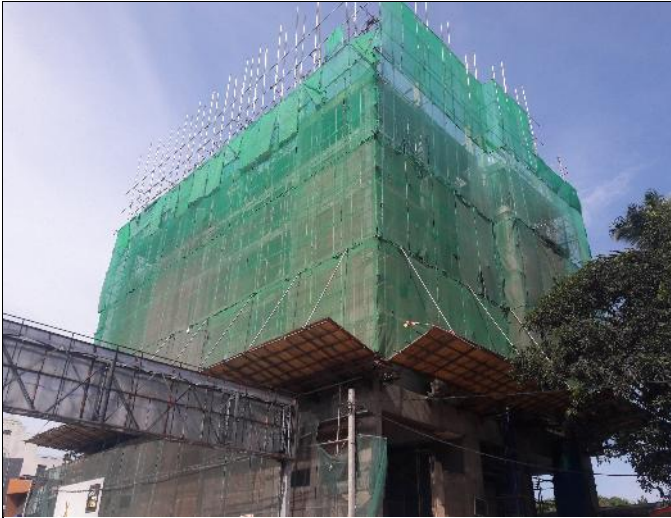
Figure 3.1- Front view from base line

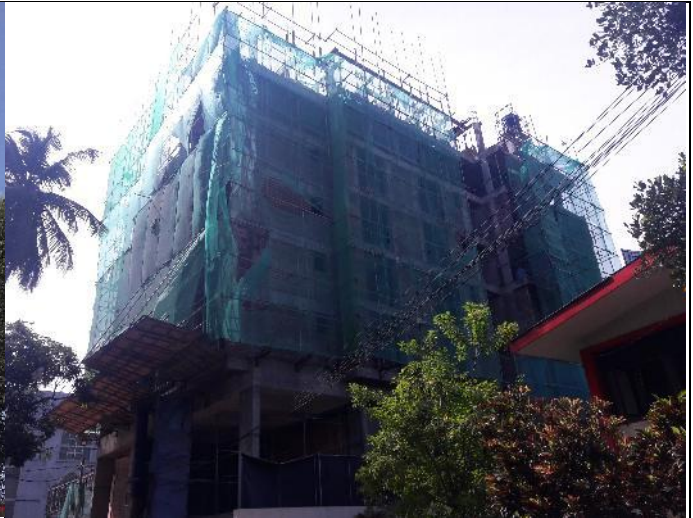
Figure 3.2 – Side view

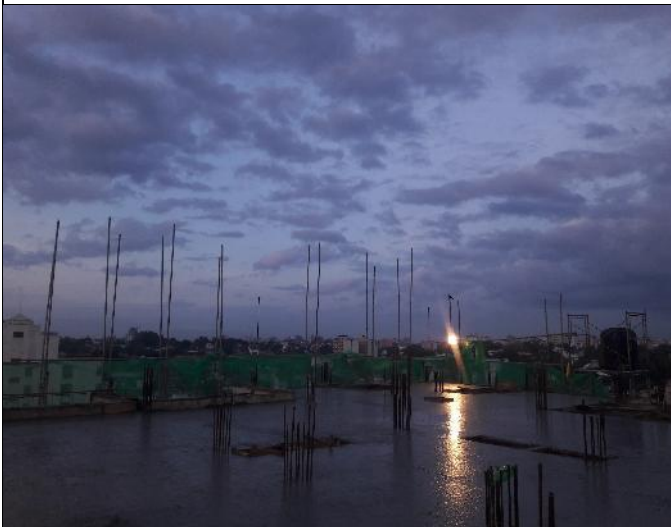
Figure 3.3- 7<sup>th</sup> floor slab casting

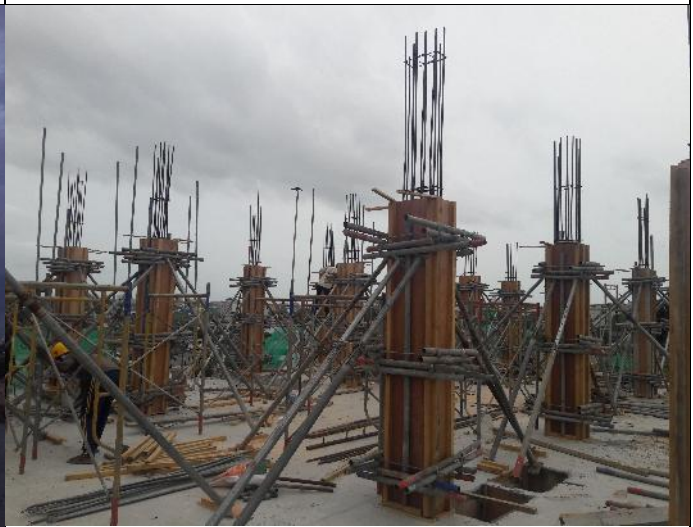
Figure 3.4- 7<sup>th</sup> floor column formwork

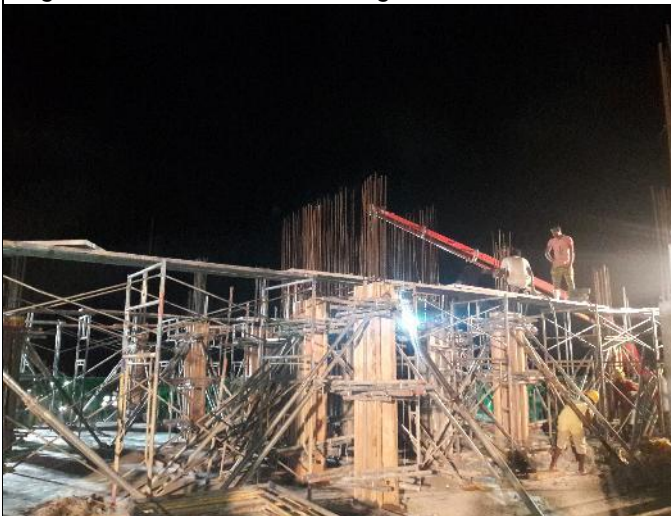
Figure 3.5-7<sup>th</sup> floor column casting

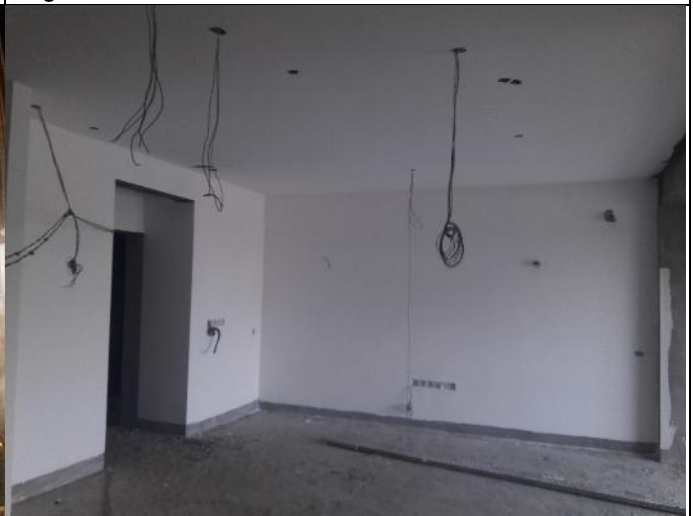
Figure 3.6-3<sup>d</sup> floor wall putty

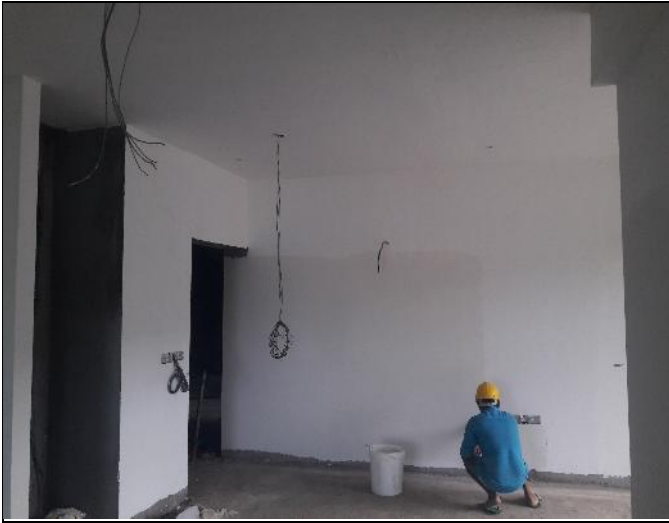
Figure 3.7- 4<sup>th</sup> floor wall putty

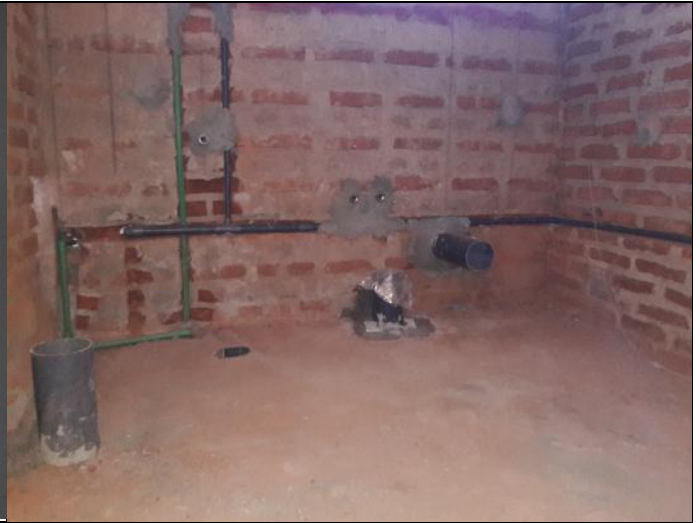
Figure 3.8 – 2<sup>nd</sup> floor bathroom plumbing

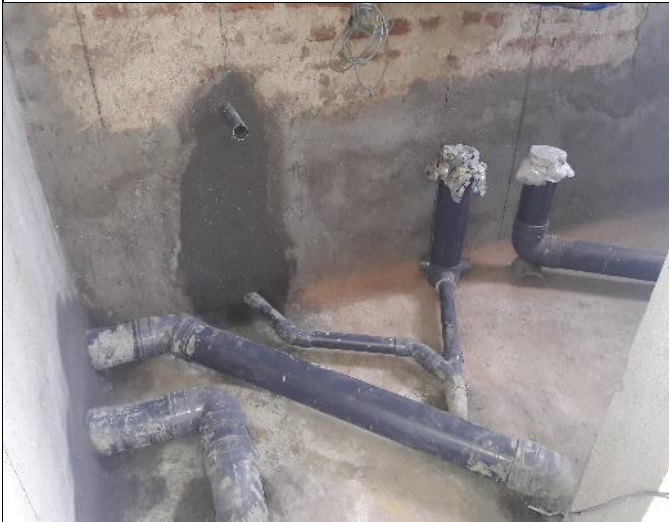
Figure 3.9- 2<sup>nd</sup> floor bathroom plumbing

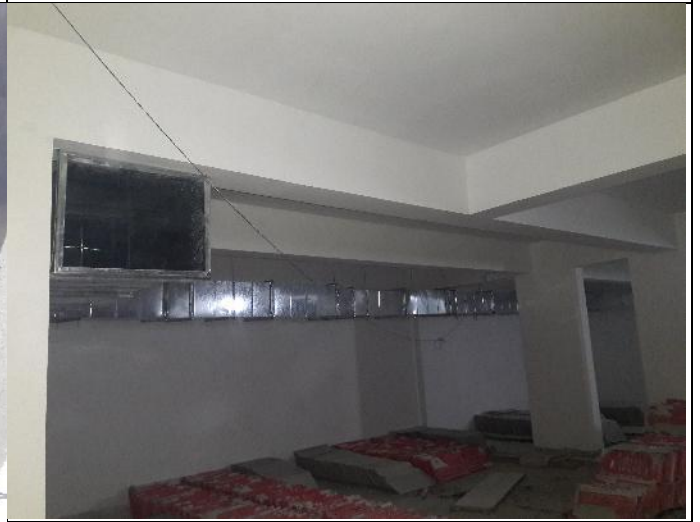
Figure 3.10-basement fresh air service

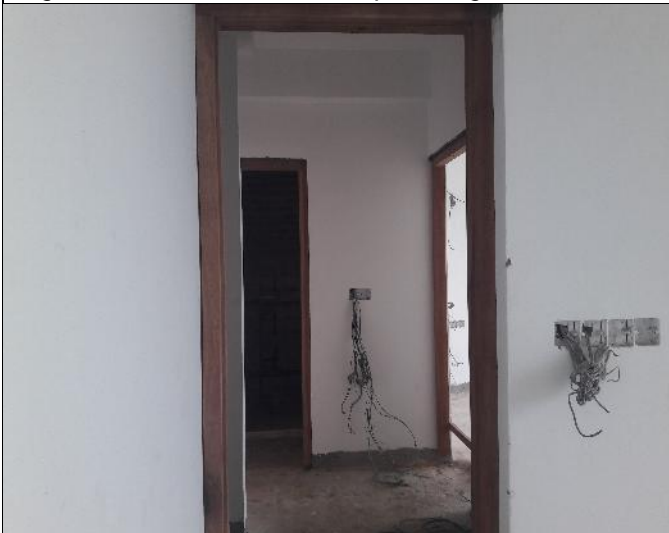
Figure 3.11- 2<sup>nd</sup> floor timber frame

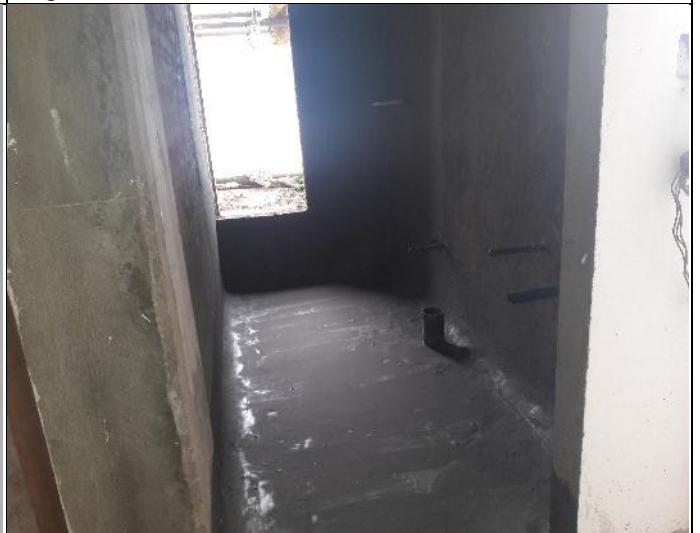
Figure 3.12-2<sup>nd</sup> floor waterproofing
